Culvert Replacement Improves Fish and Wildlife Habitat While Addressing Flooding Issues at Prospect Lake Road – Trevlac Brook

by Sara Stallard, BSc, ASCT, Envir Tech, Swell Environmental

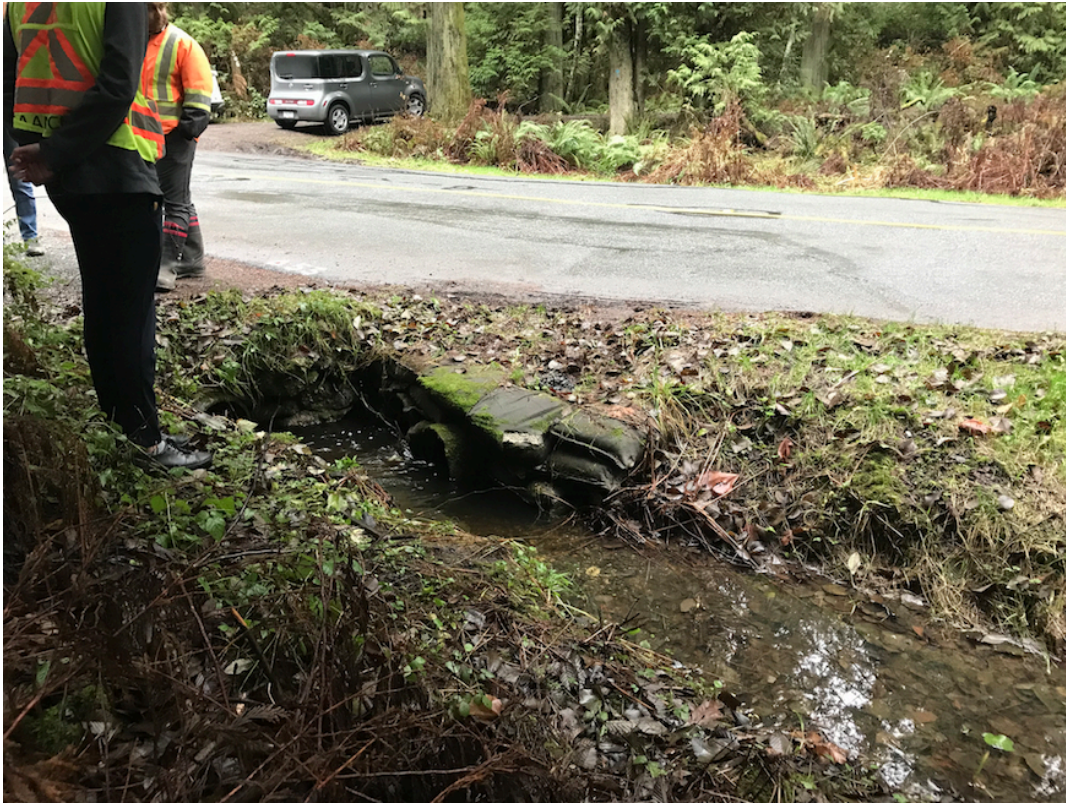
*BEFORE:
The brook
was forced
to flow
through
sharp
turns and
undersized
pipes.*

Before the improvements, the Brook was forced through sharp bends and undersized culverts. Trevlac Brook first made a nearly 90-degree turn through a small driveway culvert before turning again into two narrow concrete culverts beneath the road. These tight turns and limited pipe sizes blocked fish passage and made it difficult for small wildlife to pass safely. The undersized culverts also contributed to frequent flooding during heavy rains.

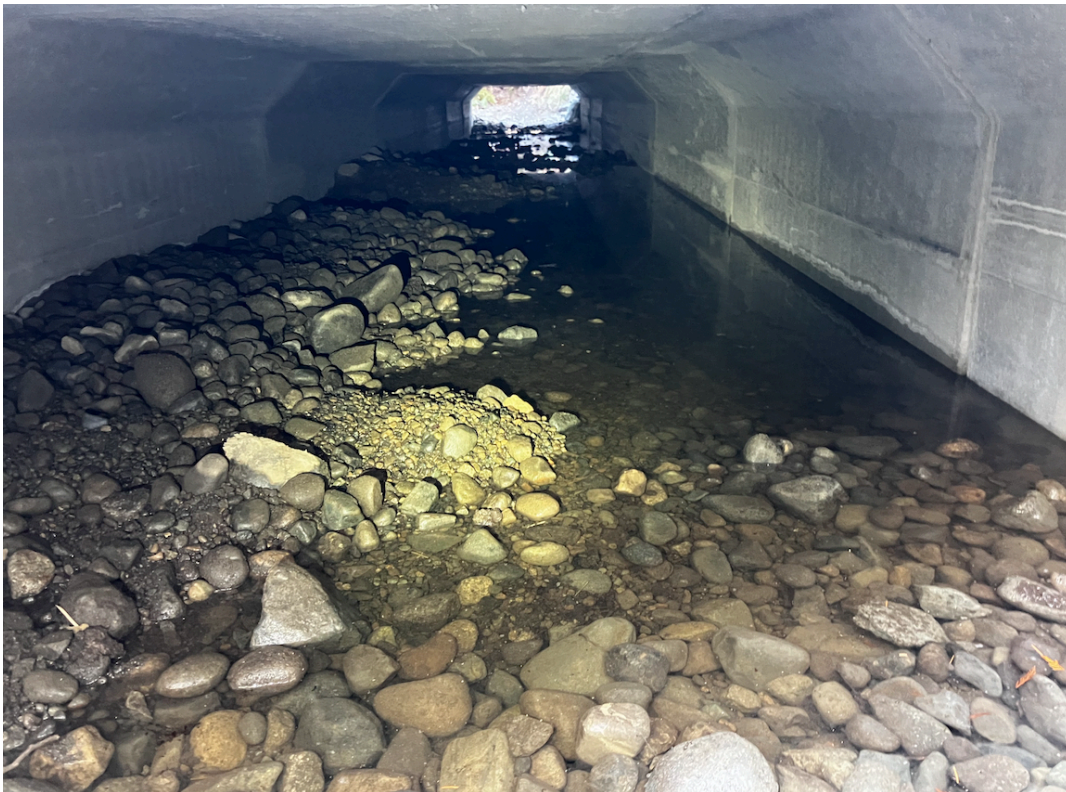
AFTER: Sand/Gravel/Cobble substrate with shallow ledge for small wildlife passage.

To improve fish and wildlife passage while reducing flooding, the old culverts were replaced with a 1.8-metre concrete box culvert aligned more naturally with the stream. It was embedded with 60 cm of rounded gravel, cobble, and sand to create a streambed suitable for Cutthroat Trout and other fish. These features also provide safe passage for amphibians and reptiles, including the Western Painted Turtle.

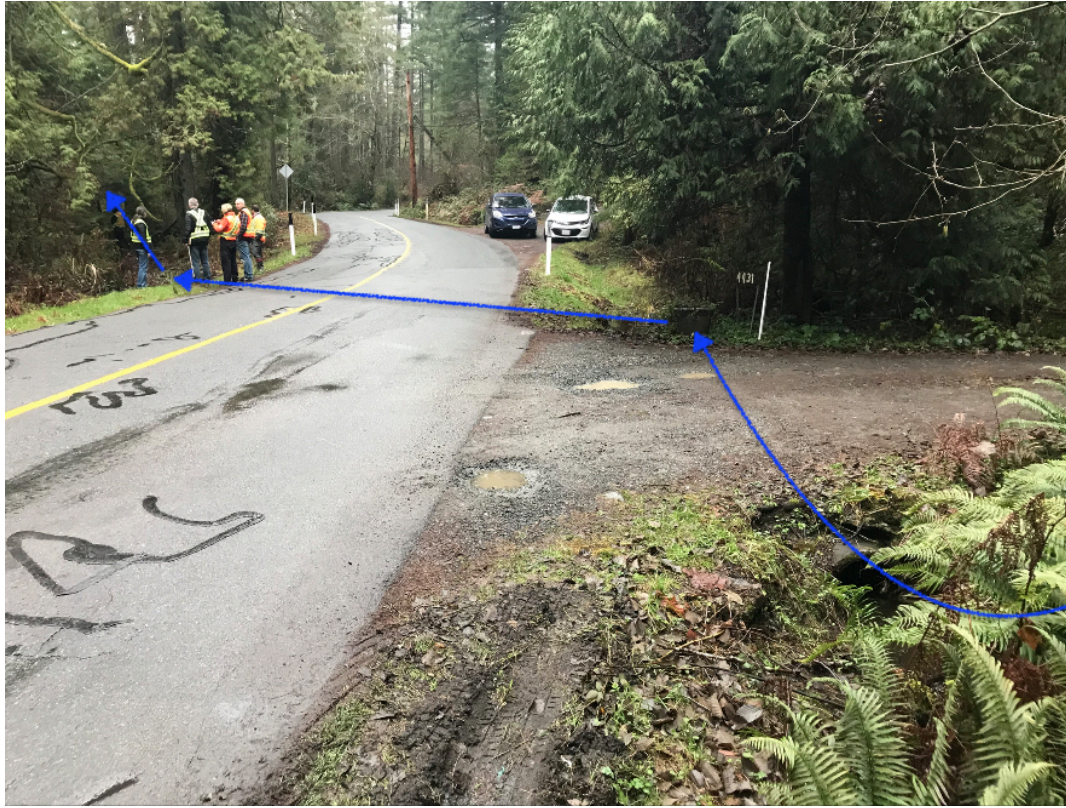
*BEFORE:
Previous
flow path
of Trevlac
Brook
through
undersized
pipes
(300-350
mm).
Road
floods
yearly.*

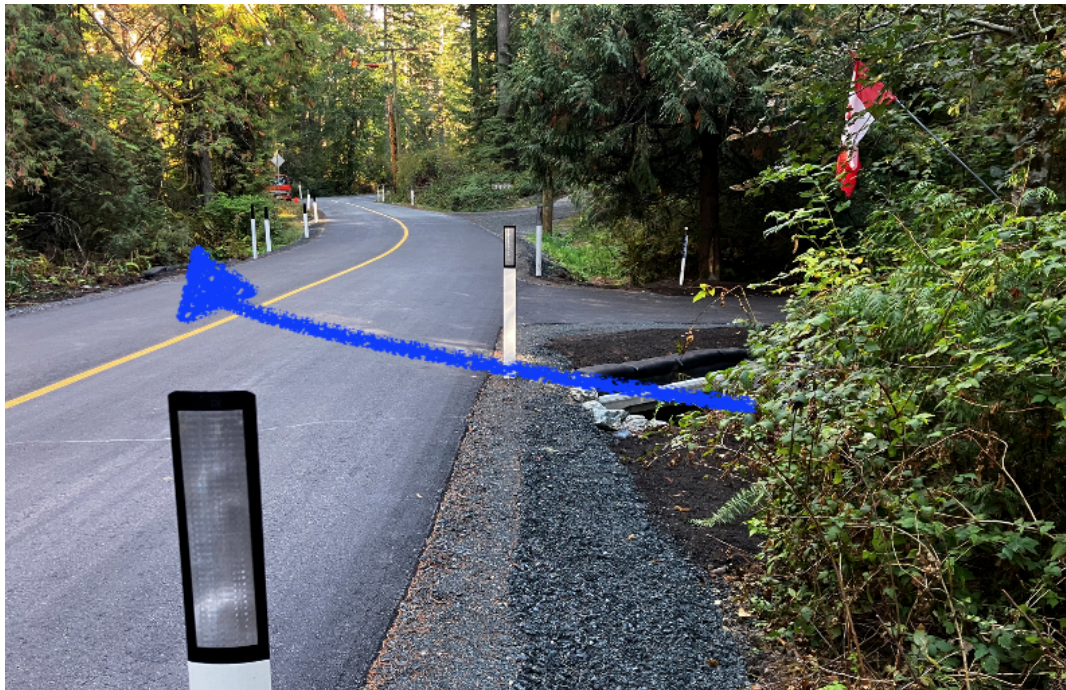
AFTER: Flow path through 1800-mm box culvert eliminates unnatural near 90-degree bends and allows stream flow to be un-impeded by culvert width, allowing for small wildlife and fish passage, and ideally eliminating/reducing yearly flooding.
